ST58SE 107

STRATA SURVEYS LTD., Telephone: 0606 834637 Fax: 0606 836657						Borehole Number : C Sheet 1 of 1.						
Job Number : 6661/2 Location : Severnside works tip. (79293) Client : ICI Ltd.						Dia. & Drilling Methods light cable percussion 150mm diameter SS21 8199						
Description of Strata	Red. Level	Legend	Thick-ness	Depth m	Sample Depths	Sample Types	N Value	Cu	ø	Water Level	Piezo-meter	Daily Prog.
TOPSOIL.			(0.30)	0.00 0.30								
Stiff brown sandy CLAY.			(1.10)	0.30 1.10	0.50 - 0.95	U-1 D-1						
Soft blue/grey slightly peaty CLAY, with grey/black slightly clayey fibrous peat bands @ 2.10m and 4.10m, and small pockets of peat.			(4.10)	1.40 3.10 4.10	1.50 - 1.95 2.10 2.50 - 2.95 3.10 3.50 - 3.95 4.10 4.50 - 4.95 5.10	U-2 D-2 U-3 D-3 U-4 D-4 U-5 D-5				▼ TSL		
Loose grey silty and clayey wet fine grained SAND.			(0.30)	5.50 5.60 5.70	5.50 - 5.60 5.60 - 5.70	W-1 B-1 D-6				▼ SLOW		
Soft blue/grey sandy and silty CLAY.			(1.20)	5.80 6.60	6.00 - 6.45	U-6 D-7

ICI Severnside Site Section along Central Avenue

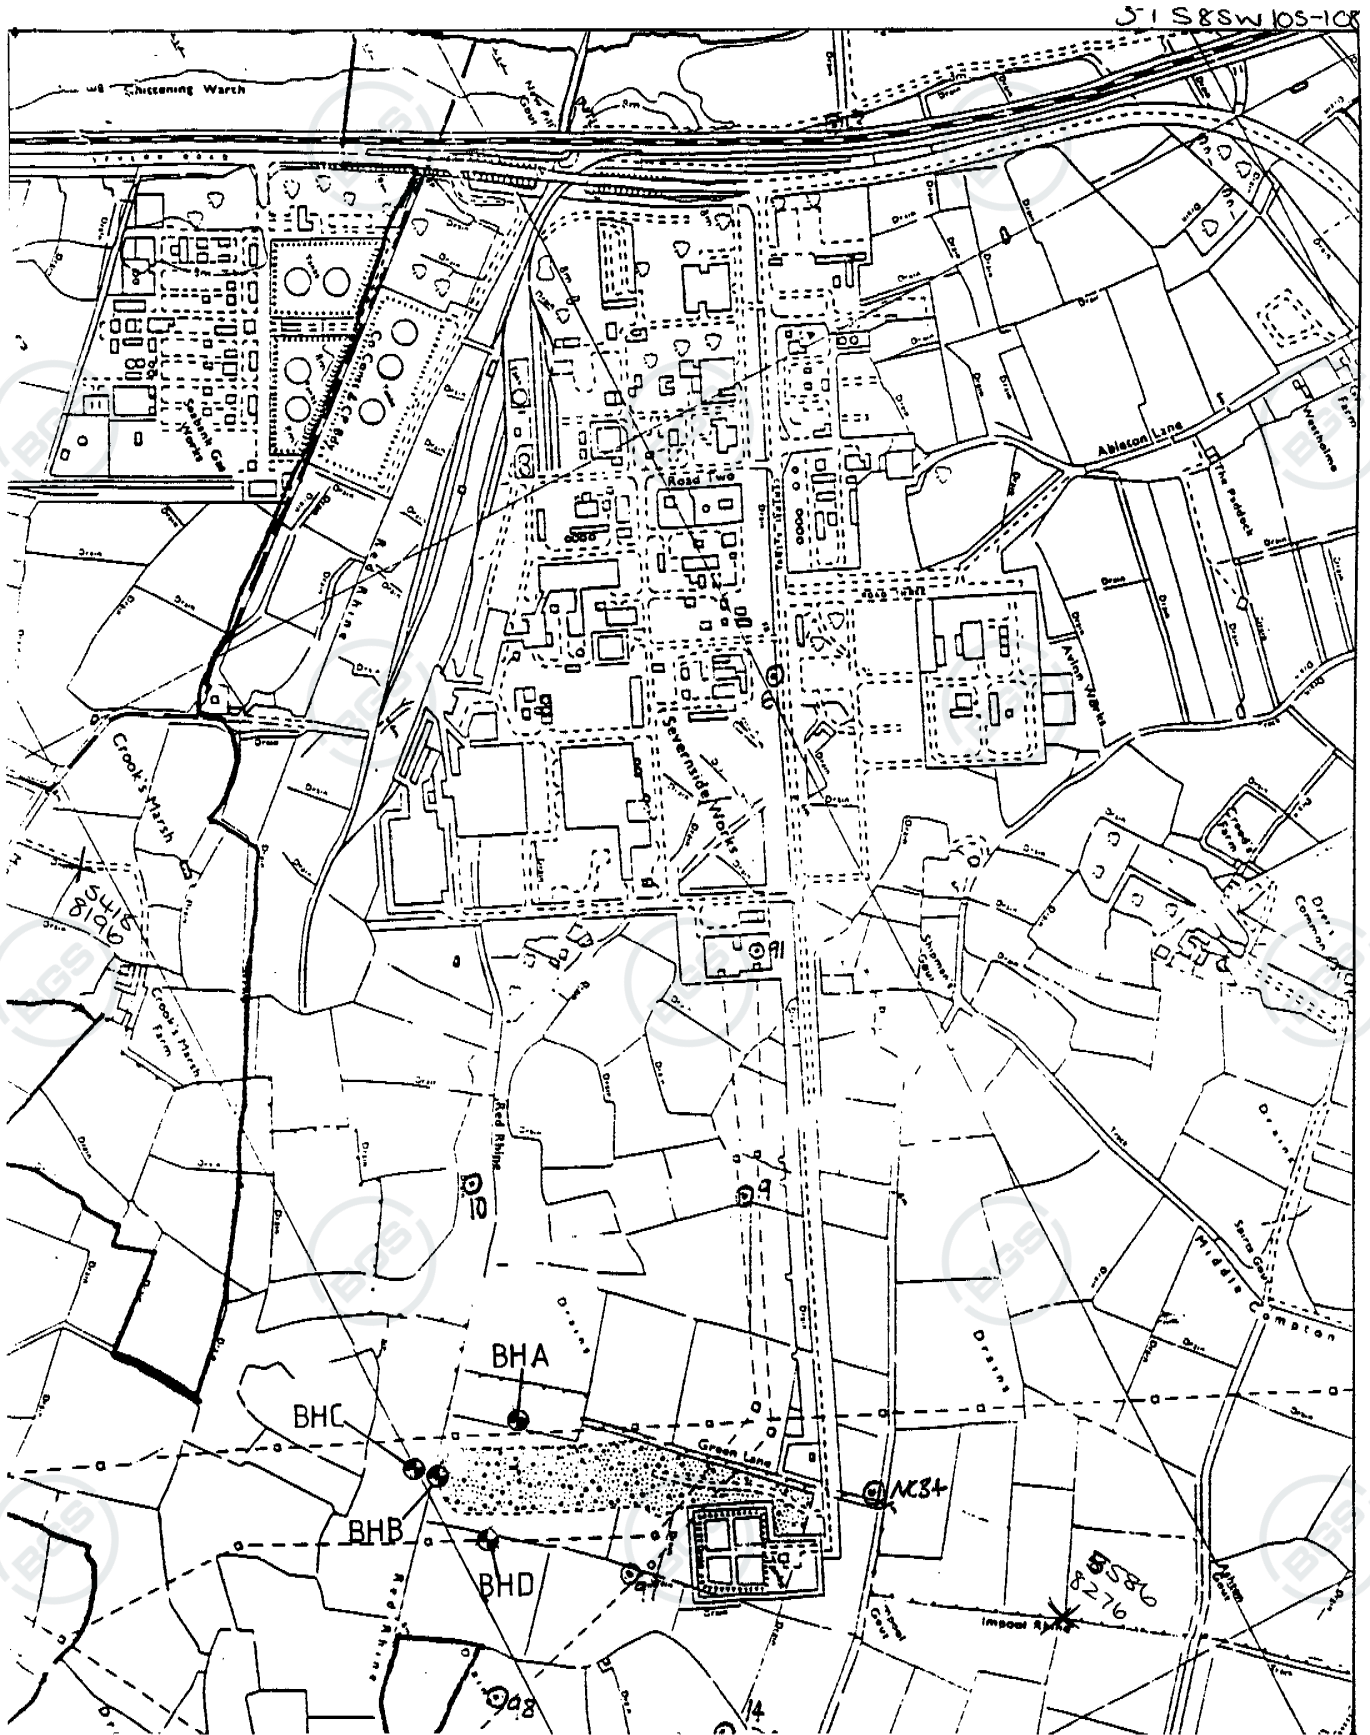
2.2 SITE PLAN
SCALE APPROX 1:1000

STRATA SURVEYS LTD.,	
Telephone: 0606 834637 Fax: 0606 836657	
Job Number : 6661/2	Location : Sevenside works tip.(79293)
Client : ICI Ltd.

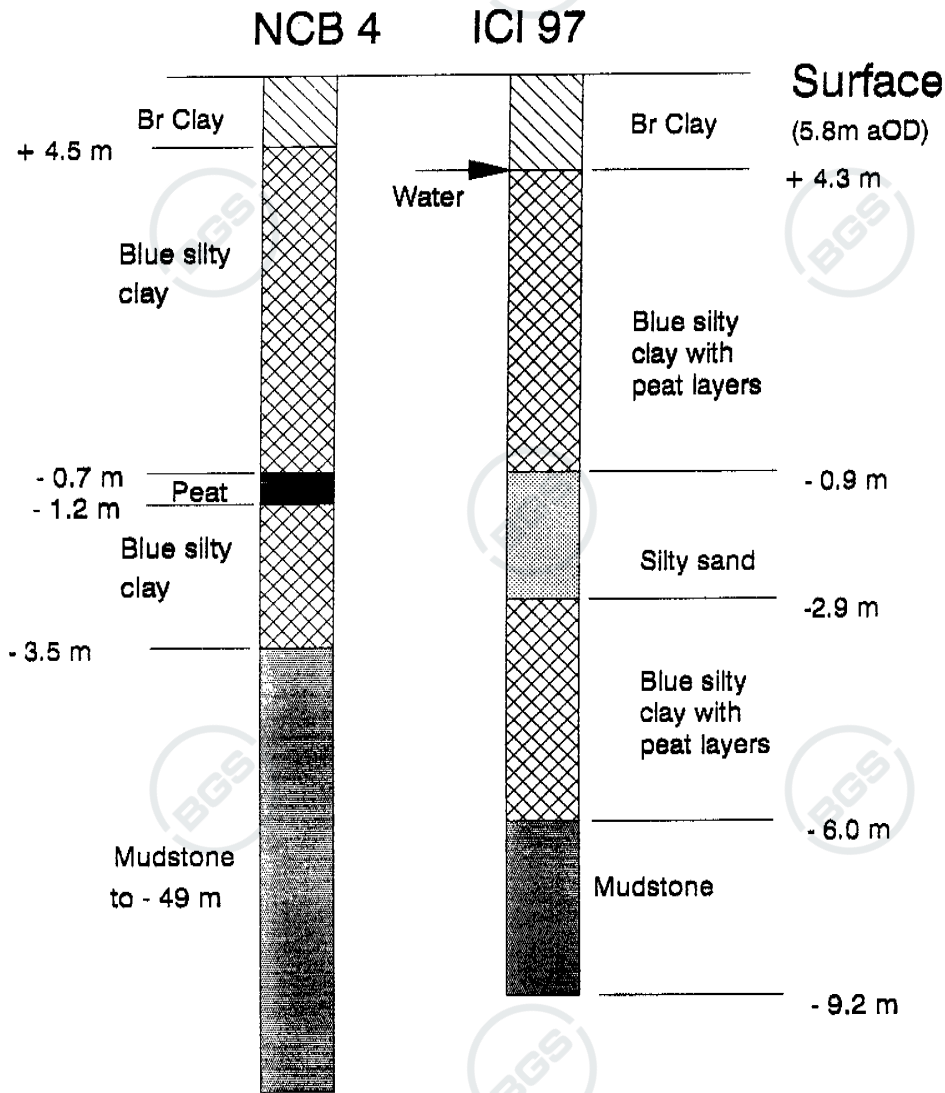
Figure 6

Geology of landfill site
